# Above Board Home Inspection Inc.

## **HOME INSPECTION REPORT**

Inspection Address

SAMPLE ADDRESS, CITY, STATE

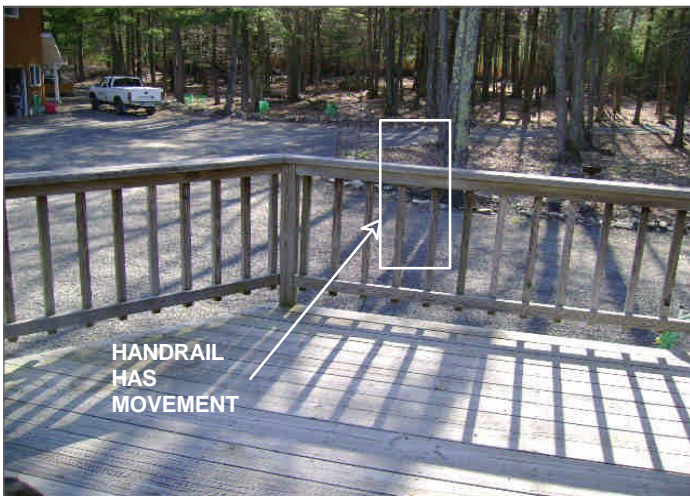
- The handrails have slight movement. The installation of additional support is recommended (nailing, screws or bracing)

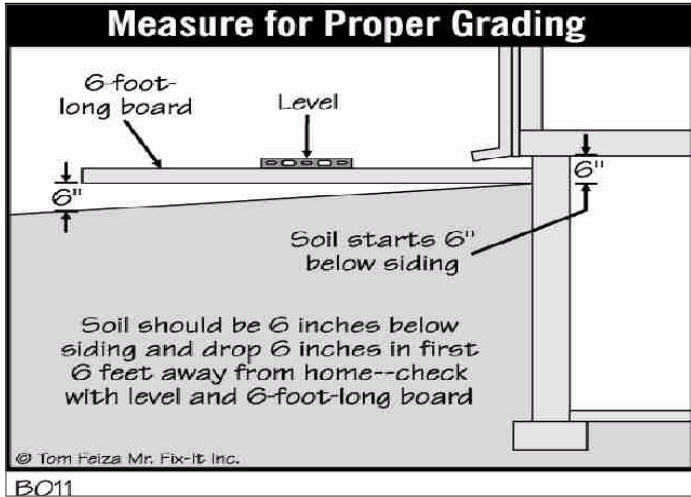
- I recommend separating siding with ground contact by at least 6 inch's to reduce the potential of wood decay and insect infestation.

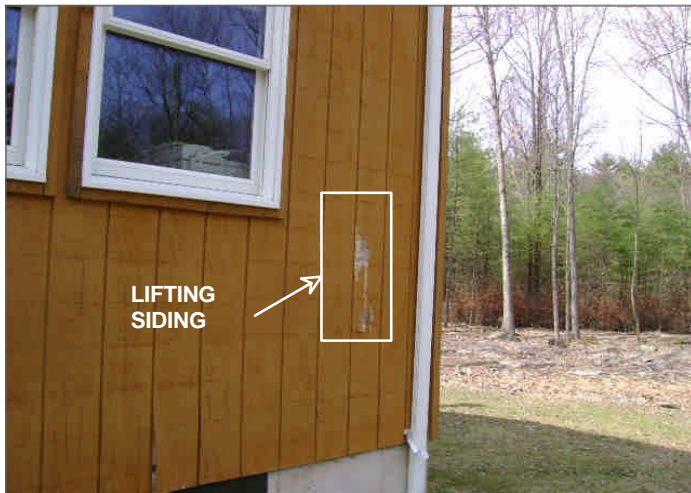
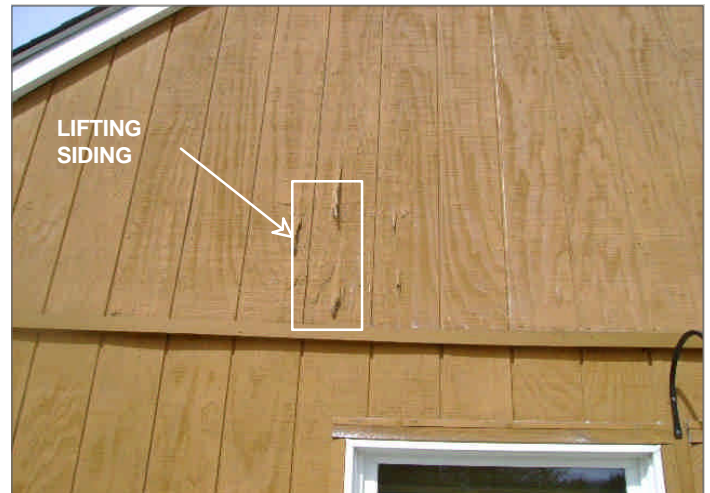
- The exterior house wall siding is in need of maintenance. Water proofing, painting, cleaning with possible hidden repair.

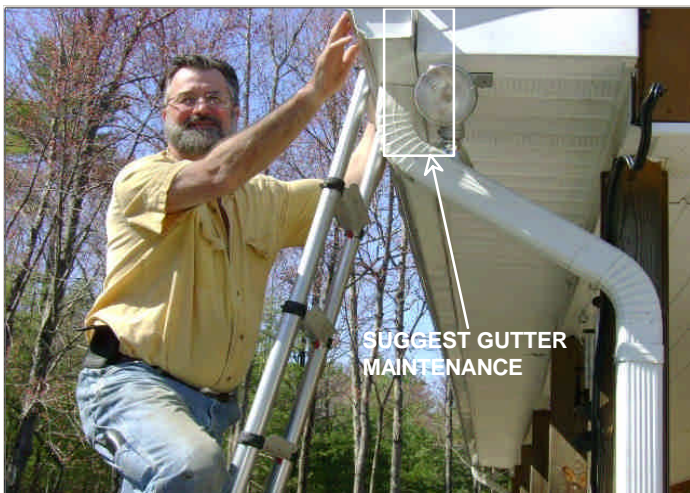
- I recommend cleaning and maintaining a full roof gutter, downspout and extension drain piping dewatering system. This will help relieve moisture accumulation against the foundation wall.

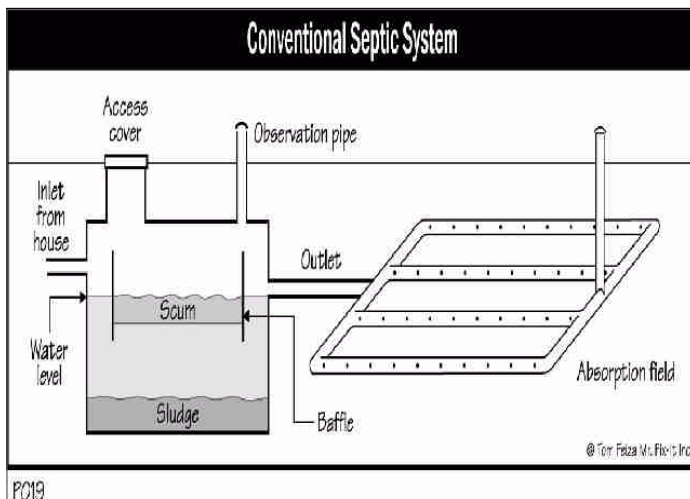
- This property is served by a private waste water system. We recommend the use of biodegradable tissue, soaps, detergents and other cleaners and that you should avoid desposing grease within the system.

Septic detention tanks periodically need pumping for removal of septic wastes. For a family of four living full time pumping should occur approx. every 3-5 years. As per our conversation. If the solid has currently been pumped. It is my recommendation that you acquire the septic company's evaluation (report) of this system. All covers on solid waste tanks, cesspools, seepage pits, drain pits and dry wells should be periodically monitored to insure that they are safely covered made of solid construction. If properly installed and maintained, a septic system should work properly for 20+years. If the system was inspected during the

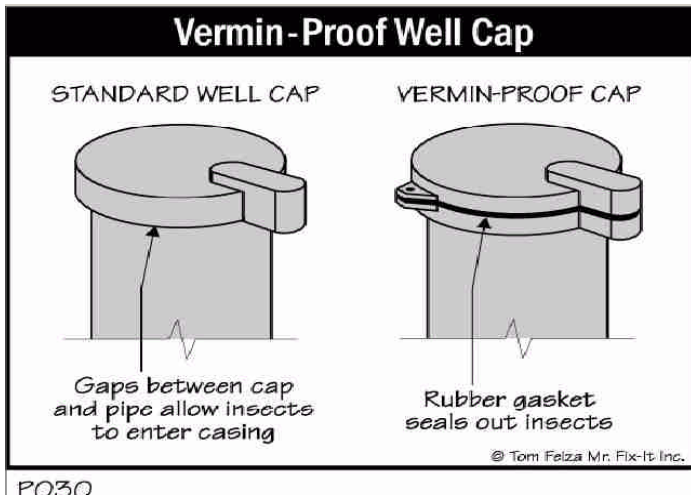
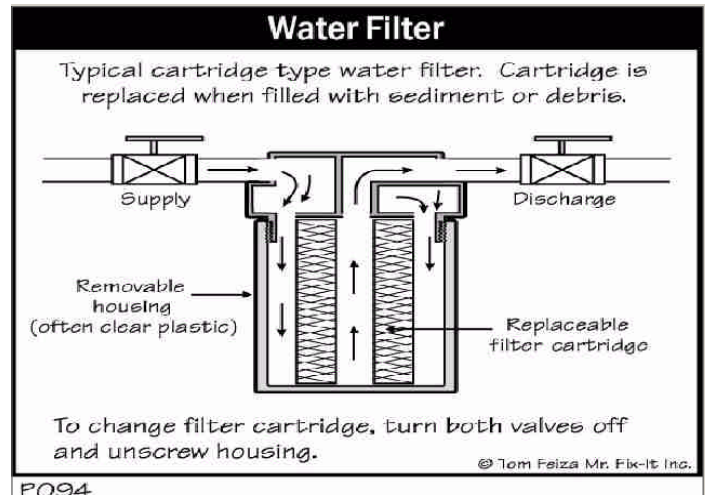
A cartridge filter is present - *Continued*

- A cartridge filter system was present. Dirty filters can harbor and promote the growth of bacteria. Routine (periodic) maintenance (replacing) cartridge filters is recommended.

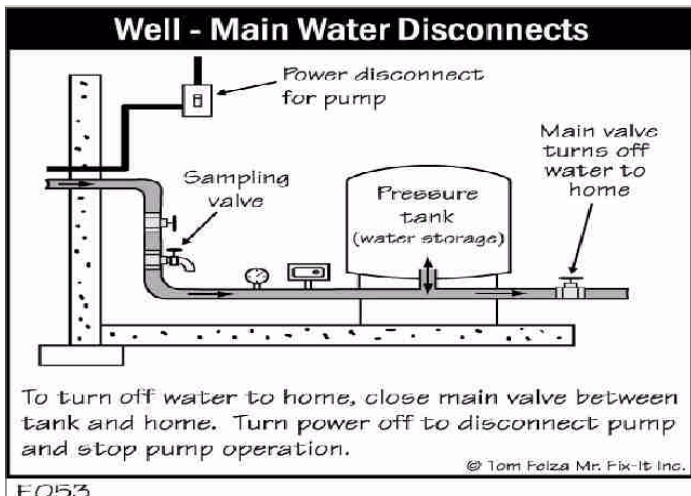
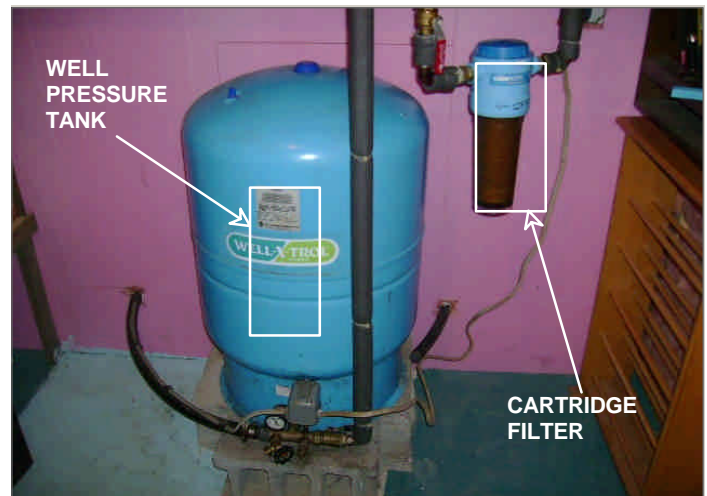
- The pressure tank is functional, and does not need service at this time.

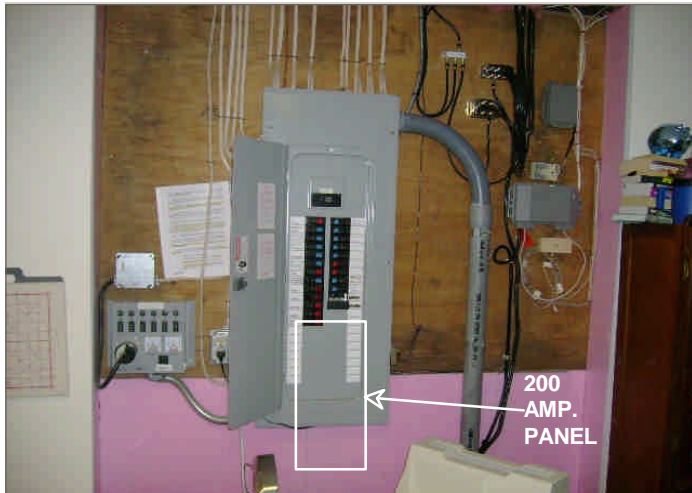
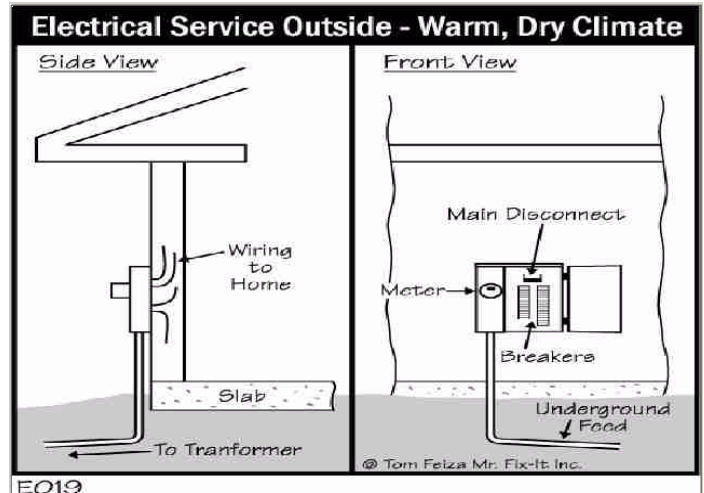
General Comments - Continued

The overhead 200 amp. 110/220 volt service is grounded. The main panel is located in the basement. The service and branch wiring are found to be functioning at the time of the inspection. Few switches or outlets did not respond. The problem being wiring, fixture, bulb, outlet or wall switch was not determined. The electrical inspection consist of the examination of exposed visible wiring only.

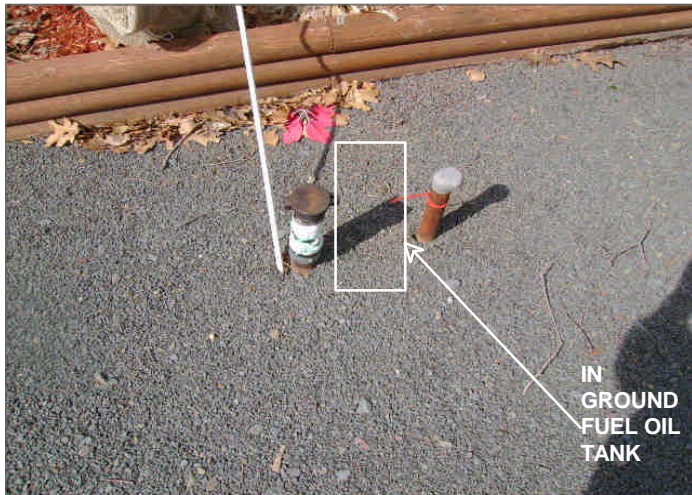
- - Inground fuel oil tank was noted

- In NY State inground fuel oil tanks are exempted. Various types of inground tank testing are available. It is my opinion that the potential for fuel oil contamination of soil is greater with an inground fuel oil tank (not visible) and more costly to remediate if a fuel oil leak occurs. I recommend the installation of an above ground fuel oil tank. Decommissioning the existing inground tank and getting inground tank insurance in the meantime.

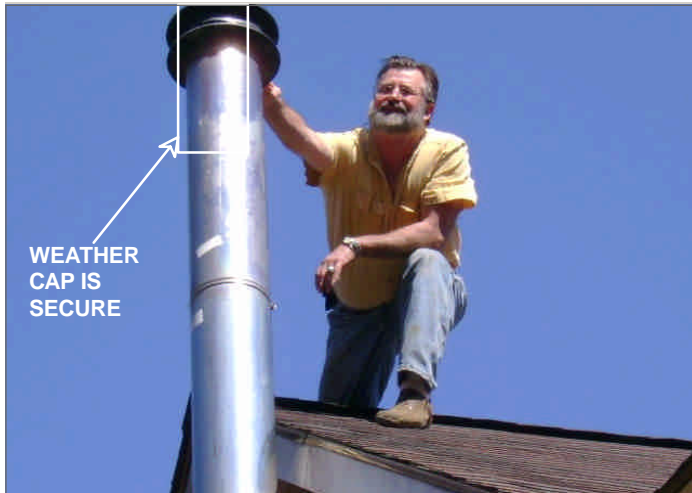
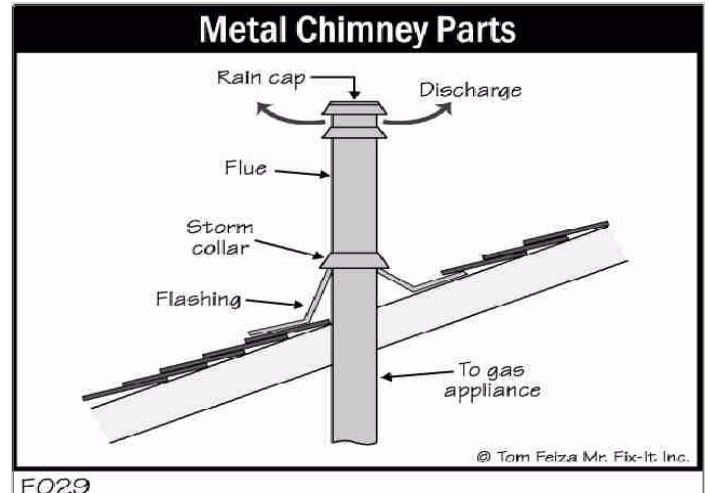
Weather cap ok - *Continued*

- The chimney has a functional weather cap/spark arrestor.

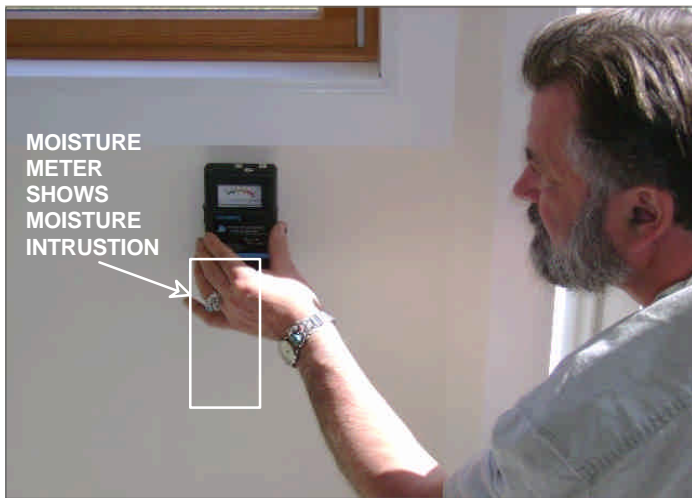
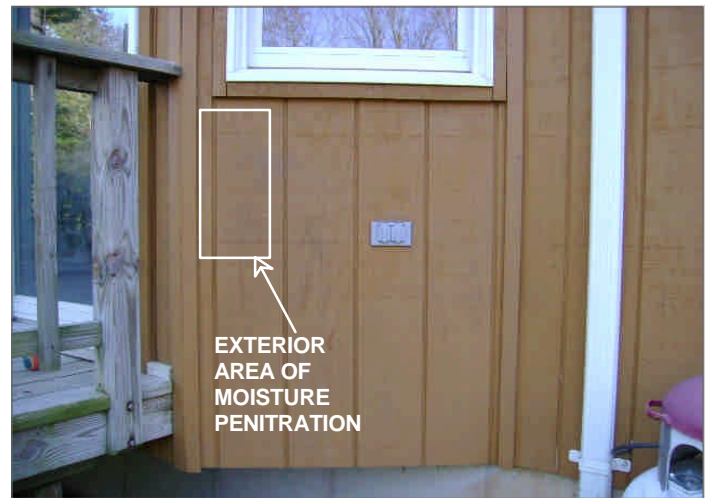
- - Moisture presence was noted below the dining room window Defect requires attention

- Moisture was noted below the dining room window. Defect requires attention.

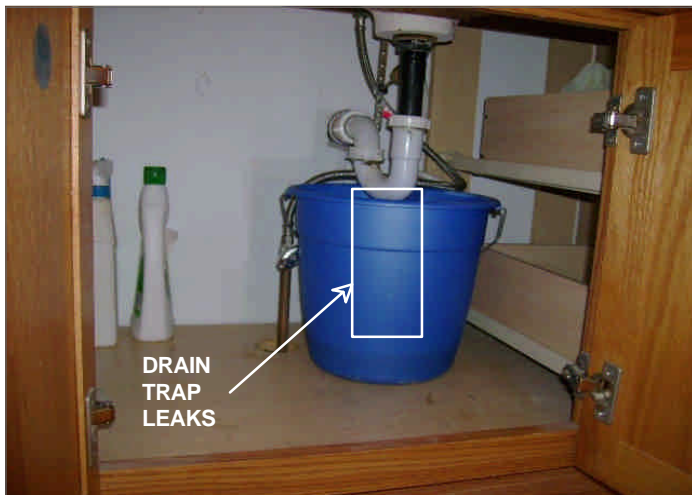
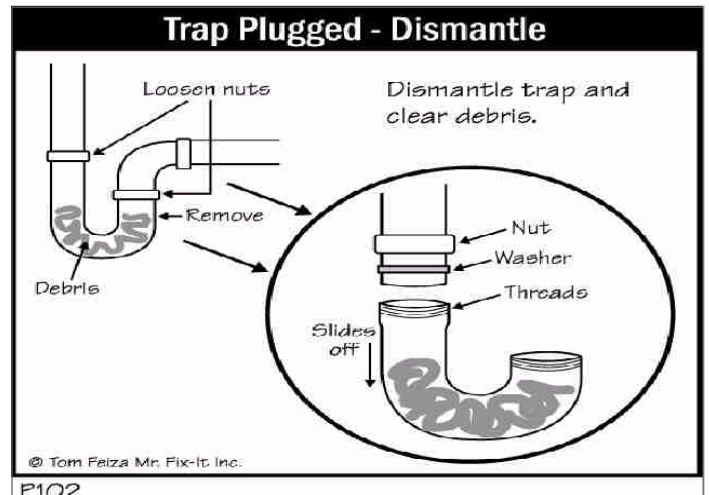
- - The vanity drain trap has leakage Defect requires attention

- The vanity drain trap has leakage. Defect requires attention

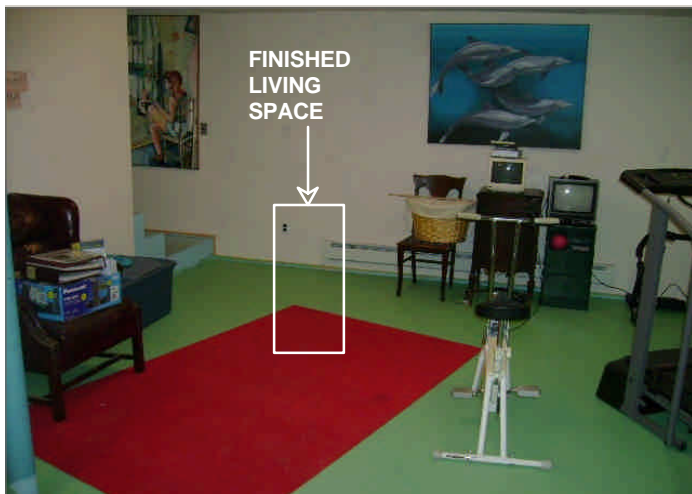
- The basement poured concrete foundation and concrete floor show slight signs of moisture and mold. This moisture has not contributed to any deterioration of the 1st. floor structural members. For mold testing I recommend contracting a Industrial hygienist or mold remediation professional. The waste disposal system is under ground and covered with soil. Therefore, it can not be fully inspected. The type of system if any is unknown.

- Due to being a finished living space the visual inspection had limitations
